# Manhole Inspection Summary

Manhole # S65S\_\_003MH

Insp Date: **3/6/08 2:01 PM**

**Location** Address: **6131 Bessemer Ave.**

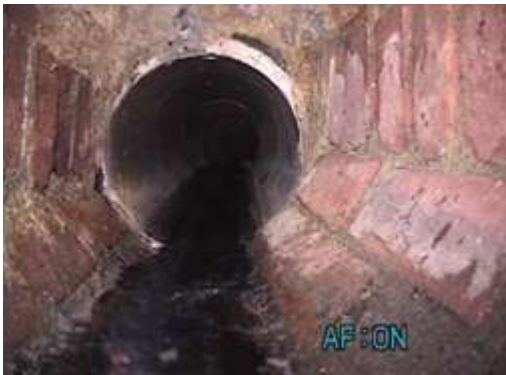
Defect 2

Cracked pipe seal 12:00-2:00 incoming 6 O'Clock

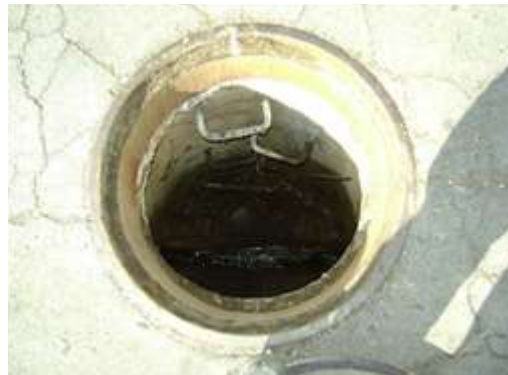
Defect 1

**Frame** Offset: **1** (in.) Condition: ☒ Sound ☐ Cracked ☐ Leaks

Offset frame defect

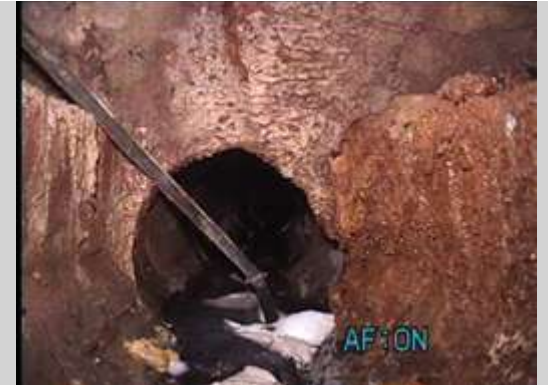
12 O'Clock Outflow

8 in. Circular Gravity Sewer  
Pipe Out @ 12 O'Clock

Pipe Height: **8.4** (in.) Rod and Bar (Angled)  
Pipe Material: **Clay** ☐ Pipe Lined  
Invert Depth: **8.50** (ft.) Flow Characteristics: **Fast**  
Deposits: ☒ None ☐ Mud ☐ Sludge ☐ Debris ☐ Grease  
Silt Depth: (in.) Deposits Extent:  
Infiltration: **None** Pipe Seal Cond: **Sound**

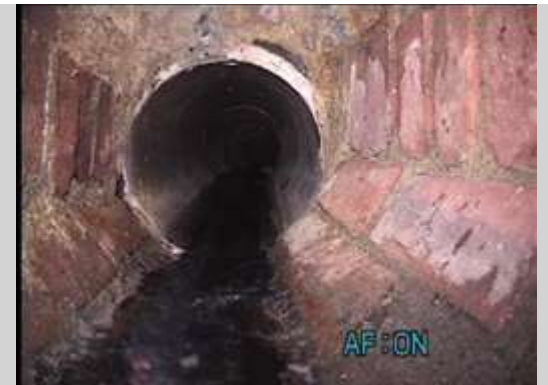
6 O'Clock Inflow

8 in. Circular Gravity Sewer  
Pipe In @ 6 O'Clock

Pipe Height: **8.4** (in.) Rod and Bar (Angled)  
Pipe Material: **Clay** ☐ Pipe Lined  
Invert Depth: **8.42** (ft.) Flow Characteristics: **Fast**  
Deposits: ☒ None ☐ Mud ☐ Sludge ☐ Debris ☐ Grease  
Silt Depth: (in.) Deposits Extent:  
Infiltration: **Evidence** Pipe Seal Cond: **Broken**
